The Very Image of the Past

Old Photographs and the Restoration of Historic Railroad Equipment

Kyle K. Wyatt

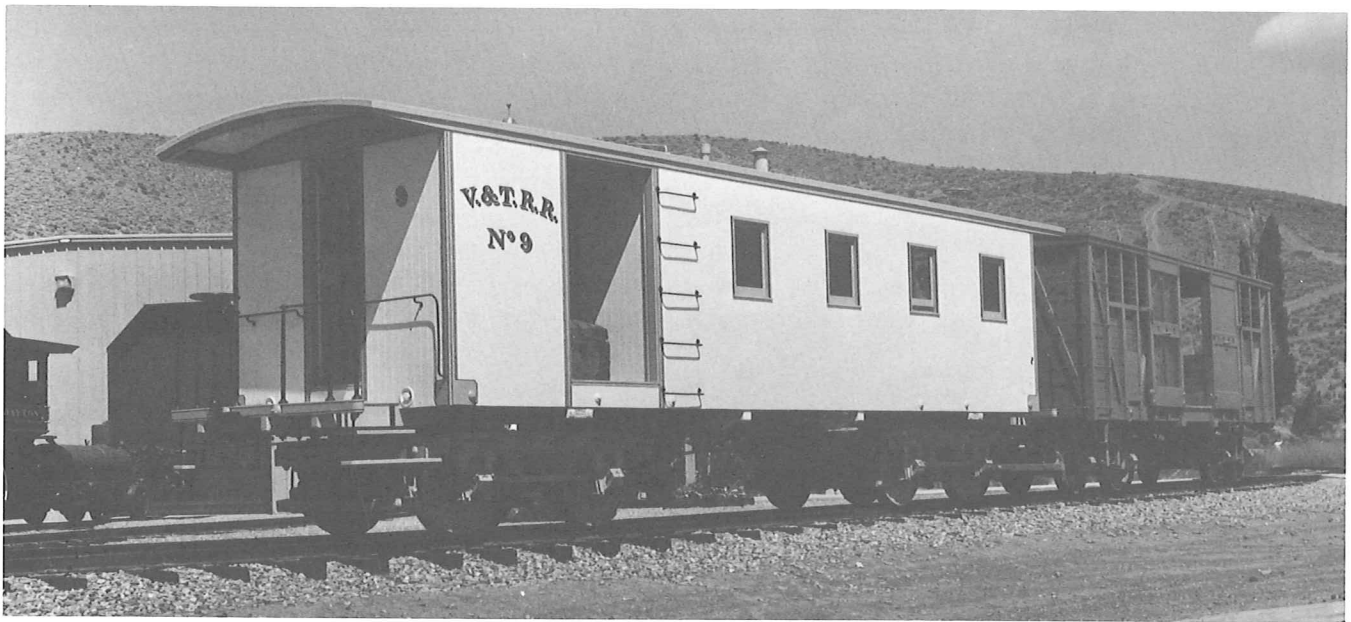
Figure 3 — Virginia & Truckee coach-caboose #9, restored to its original 1873 appearance by the Nevada State Railroad Museum. Early cabooses frequently were used in third class passenger service. The print is from a modern 4x5 negative. (Photo, Daun Bohall, Nevada State Railroad Museum collection, Carson City, NV)

Figure 3 shows Virginia & Truckee coach-caboose No. 9 as restored to its original 1873 appearance for the Nevada State Railroad Museum. In the 19th century, many cabooses were set up for third-class passenger traffic. As there are no known photos of car No. 9 or its twin No. 10 during this period, the restoration was based primarily on the results of physical and documentary research.

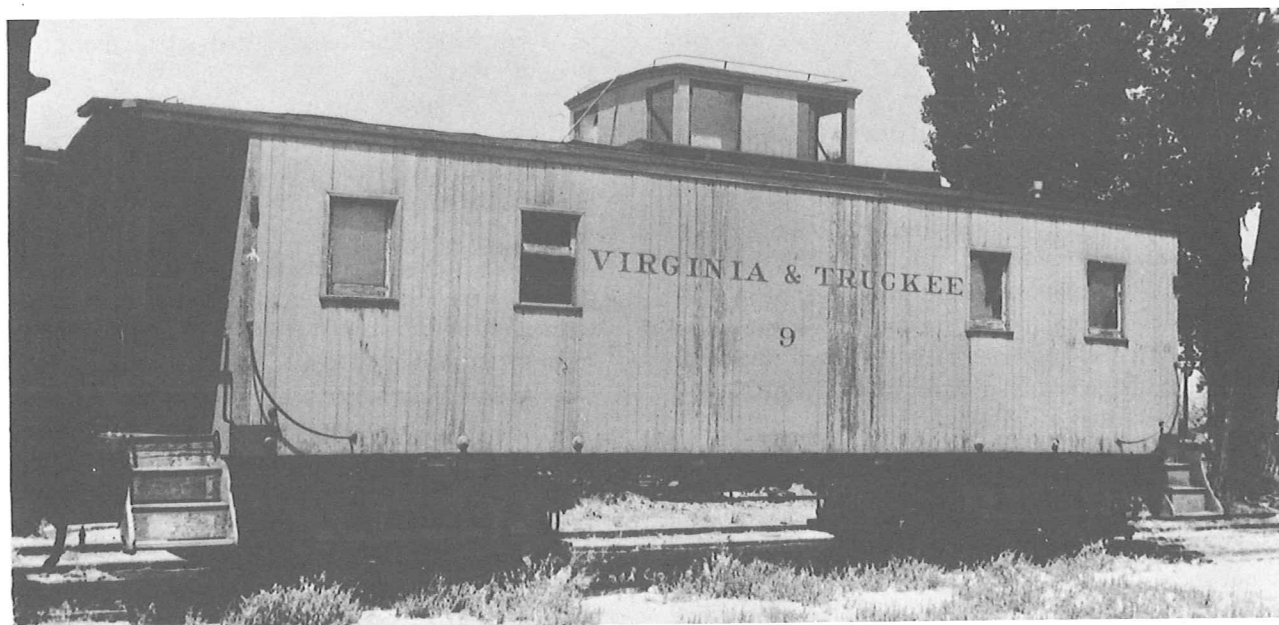
Figure 5 — Virginia & Truckee caboose #9, ca. 1937. This shows how car #9 was rebuilt in 1913 into what we more commonly consider to be a caboose appearance. This photo is from a modern copy negative of a second or third generation print. (Photo, Nevada State Railroad Museum collection, Carson City, NV)

Figure 5 shows Virginia & Truckee caboose No. 9 as rebuilt in 1913 with a cupola in the center of the roof, a configuration we commonly associate with more modern cabooses. The car remained this way until 1938, when Paramount studios purchased it and removed the cupola for the movie *Union Pacific*. The photo was taken *ca.* 1937, with No. 9 also painted Kodak yellow.

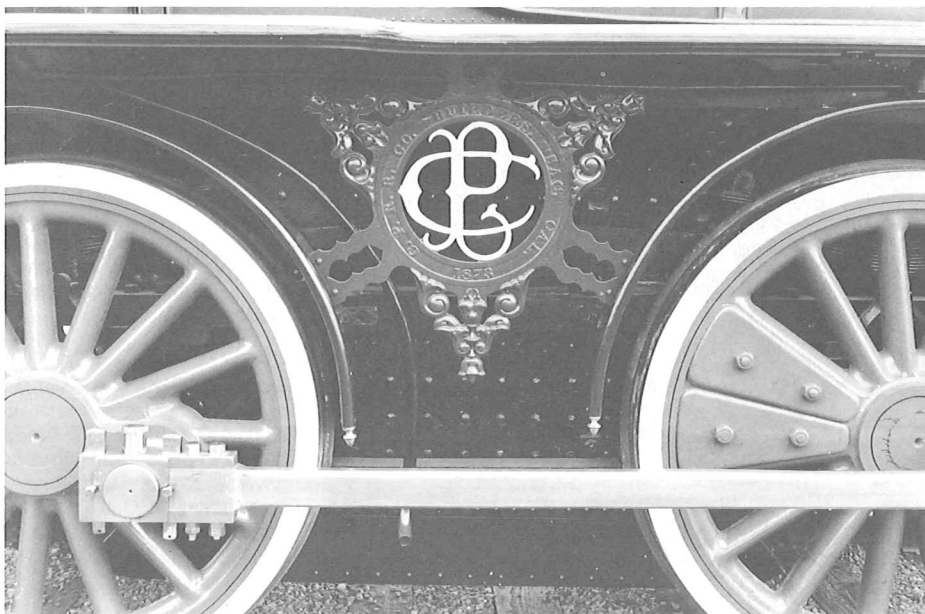
Figure 9 — Reproduction builder's plate cast for the restoration of Virginia & Truckee locomotive #18 to its ca. 1882 appearance by the Nevada State Railroad Museum. V&T #18 was built in the Central Pacific shops in 1873, shortly after Central Pacific second #55 was completed. Photo from a modern 4x5 negative. (Photo, Bob Dockery)

For a final example, look at Figure 9, the modern panchromatic image of the reproduction builder's plate on Virginia & Truckee locomotive No. 18. In color, the

letter “C” is painted white, while the “P” is a golden yellow. For reference, the basic plate is a medium forest green. Looking closely at the original paint, there is scarcely the slightest hint of gray to indicate that the “P” is anything but white like the “C.”

Museum used the enlargement of Figure 7, presented here as Figure 8, to develop a pattern for casting a reproduction of the fancy plate located between the drivers. Figure 9 shows the completed reproduction casting. Comparison of the plates in the two photos shows how the historic photo was interpreted in making the modern pattern. While the basic form is clear in the historic photo, questions such as whether to use flat-faced letters or round-faced letters are more difficult to answer. Unanswered by the photo is whether the plate is cast in bronze or in iron; the reproduction is in iron.

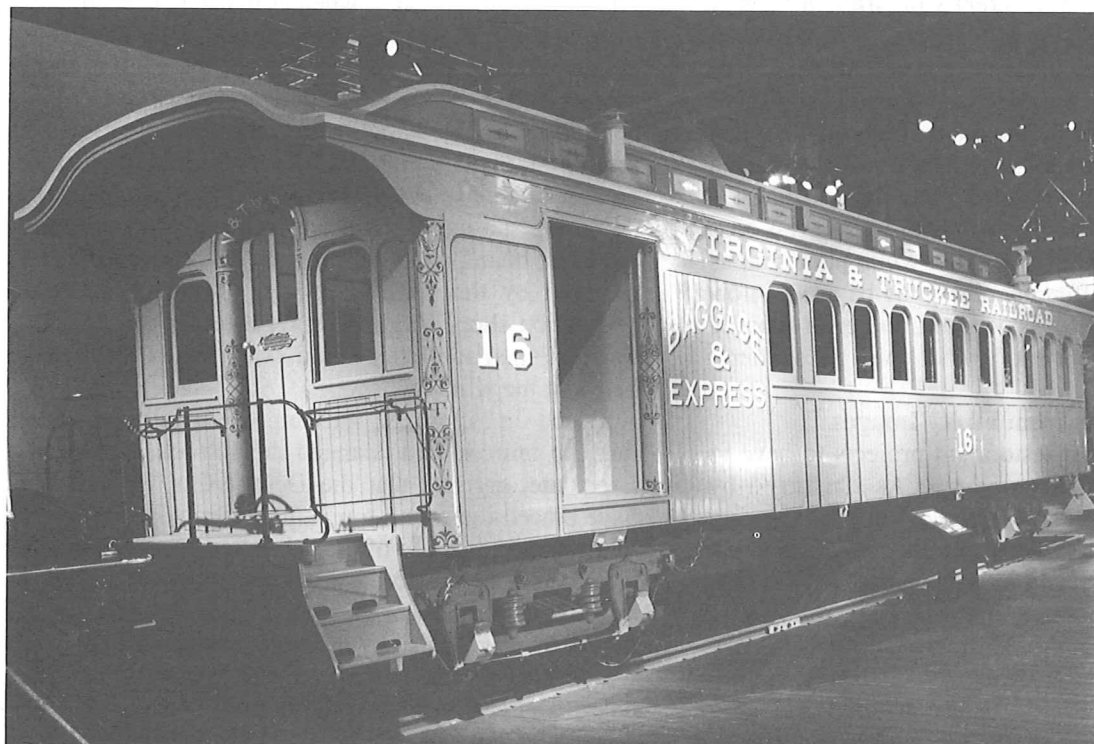
Figure 11 (left) — Virginia & Truckee combine-caboose #16 as restored to its 1874 appearance by the California State Railroad Museum. Photo from a modern 4x5 negative. (Photo, California State Railroad Museum, Sacramento, CA)

Note also the dark drop shadowing on the letters and the striping on No. 16 (perhaps hard to see in the half-tone reproduction presented here). Contrast this with Figure 11, showing No. 16 as restored to the same time period by the California State Railroad Museum. In this print from a modern panchromatic negative, the green car appears much lighter than in the old wet-plate image. Physical research showed that No. 16 has *double* drop shadowing, consisting first of a wine line followed by a red line. In Figure 10, these appear together as a single large dark line. In the latter, the wine line is clearly visible, but the red line is almost the same shade of gray as the green car and is all but invisible. There is also red striping detail on the end of the letter board, but it is hardly noticeable in the photo. Green and red may both be light in a panchromatic image instead of dark as in a wet-plate image, but they are actually easier to distinguish from each other in the wet-plate.

Based on Figure 10, museum researchers concluded that the railroad had changed the sub-letter board at a later date, arguing that the Detroit Car Works would have placed the round-top painted figure under an arch in the bottom section of the sub-letter board. This is the way the car was restored, as illustrated in Figure 11.
