Johnson & Pollock Lumber Company

Jerome, California
36" gauge logging railroad
Eastern extension
circa 1914-1918

*Written, photographed and
illustrated by Scott Gavin © 2010*

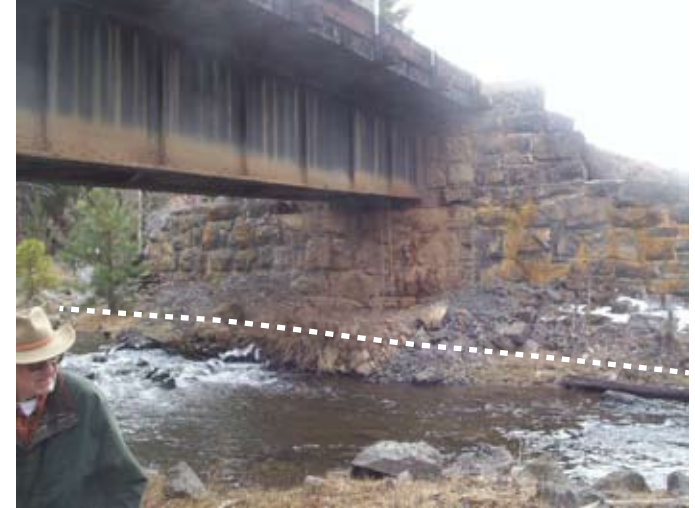
Photo A: Jack Bowden at the Southern Pacific bridge across Butte Creek. The J & P logging railroad passed under this bridge on the far bank. Dashed line indicates railroad grade. February, 2006

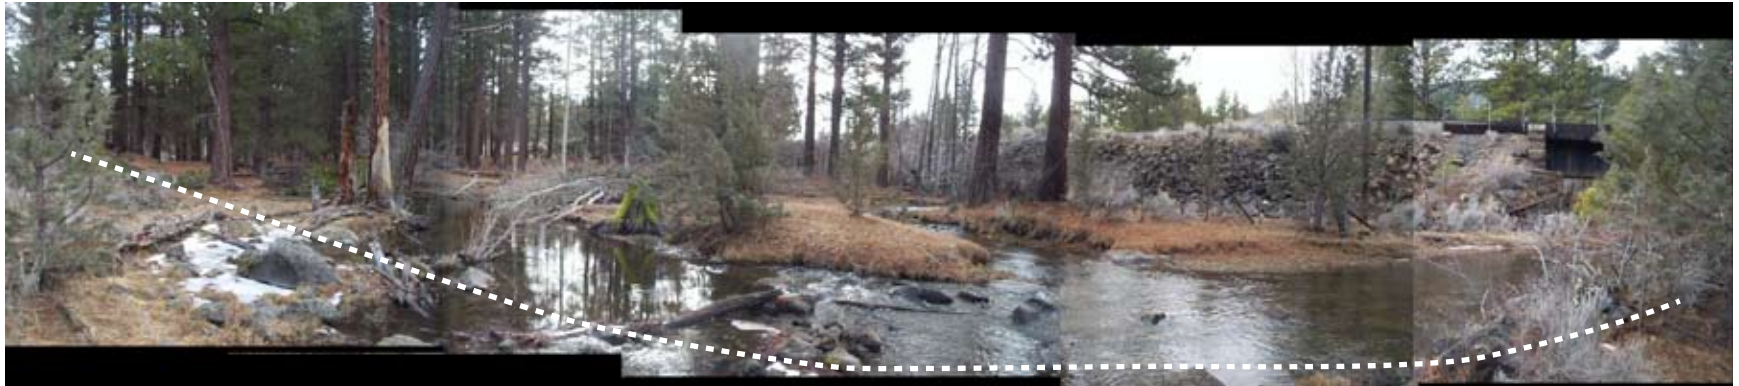
Panoramic mosaic of the eastern approach to the Johnson & Pollock Lumber Co./Southern Pacific underpass at Butte Creek. February 2006. High water has partially flooded the railroad grade in the foreground. Dashed line indicates the location of the railroad grade. Photos by the author.

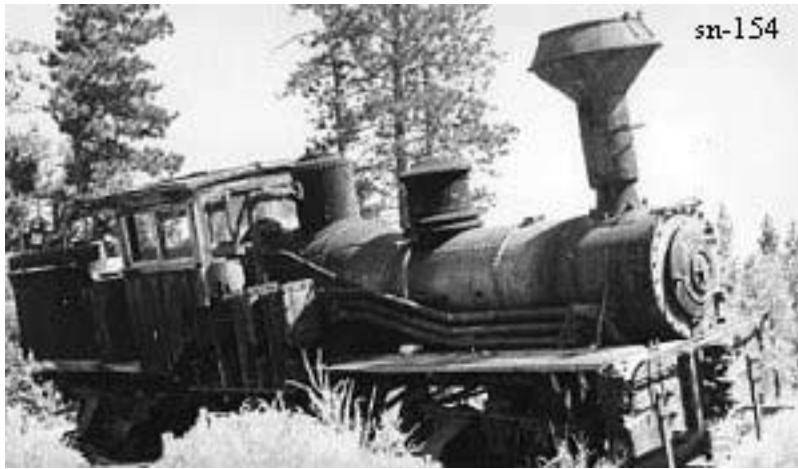
*Shay locomotive No. 154, abandoned in the woods near Jerome.
Photo: www.shaylocomotives.com*

The Johnson & Pollock Lumber Co. acquired a narrow-gauge Shay locomotive for use on their railroad. This locomotive was an early Shay, builder's number 154, constructed in 1886 for the Mason & Oceana Railroad in Michigan. The locomotive was sold to the Brookings Lumber Co. in Fredalba, California in 1900. This company moved its operations to the southern Oregon coast in 1913, to a town it established and named "Brookings". Shay No. 154 was sold to the Johnson & Pollock lumber company in 1913.

The gauge of this locomotive is in question. Records of the Lima locomotive works list the engine as being built to 36" gauge. Various sources claim that the Shay was regauged to 30" when it was sold to the Johnson & Pollock Lumber Co. while other sources claim that it was never regauged. In 2006 and 2010, this author measured spike holes on surviving ties found along the Johnson and Pollock railroad and was able to establish the gauge of the railroad as 36".

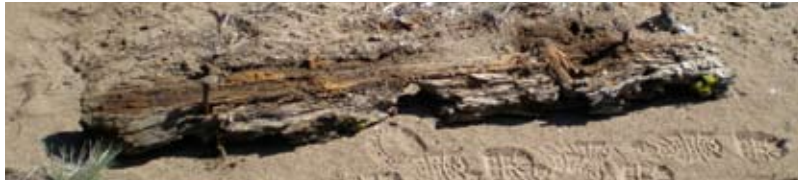
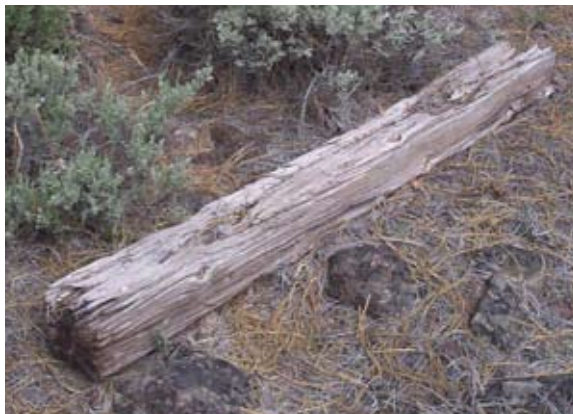
Photo B (above) and Photo C (left): Surviving railroad ties with spikes and spike holes allowed the gauge of the line to be established at 36" between the rails. Photo B: April, 1010, Photo C: June, 2006 by the author.

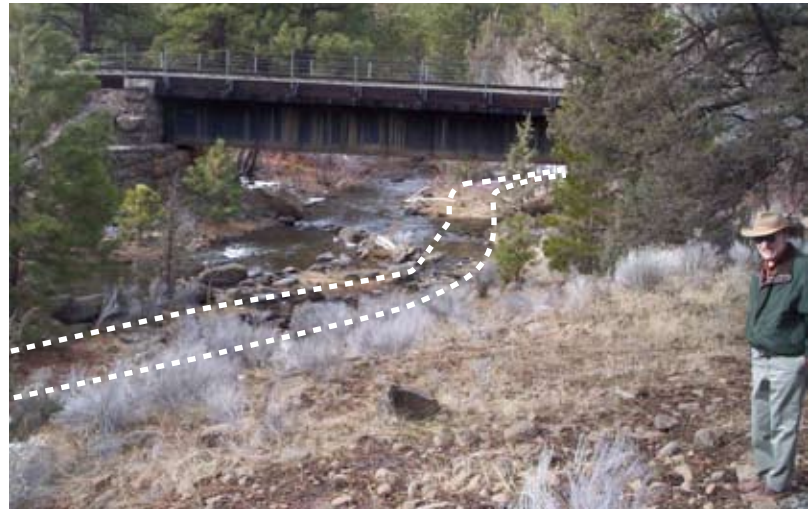
Jack Bowden at Southern Pacific Butte Creek Bridge, February 11, 2006. Photo by author. Dashed line indicates location of railroad grade.

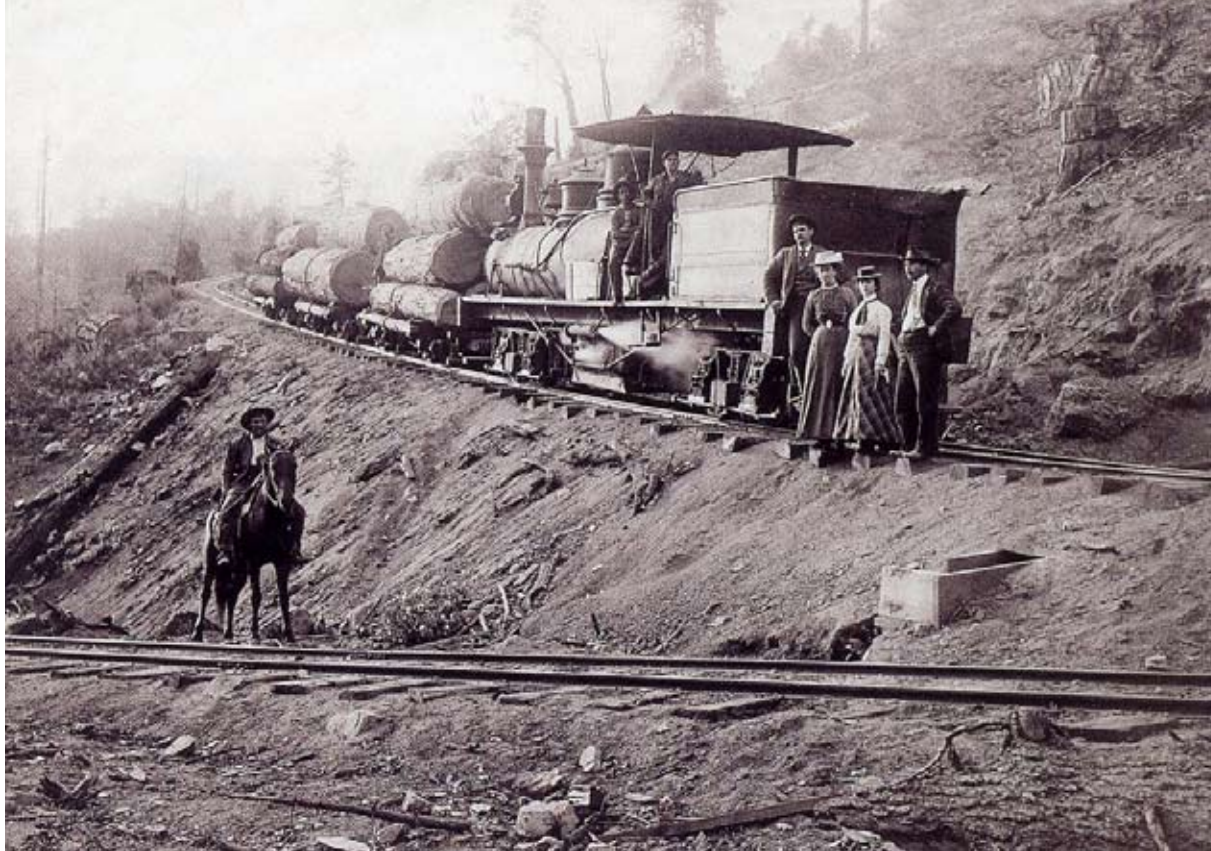
Shay locomotive No. 154, identified as on the Johnson & Pollock logging line. However, there are no known switchbacks on the Johnson & Pollock railroad, so this was probably taken on the Mt. Hebron Lumber Co. railroad on the side of Ball Mountain. Photo: California State Library

However, to confuse the issue, the Shay locomotive was later used on the nearby Mt. Hebron Lumber Co. railroad on Ball Mountain. Examination of surviving ties on the Ball Mountain railroad established the gauge of that line at 30". All sources seem to agree that the Mt. Hebron Lumber Co. not only used the Johnson & Pollock Shay, but the Johnson & Pollock's small fleet of logging flat cars as well. Why the Mount Hebron Lumber Co. would have reduced the gauge of the Shay and the flatcars by six inches remains a mystery.

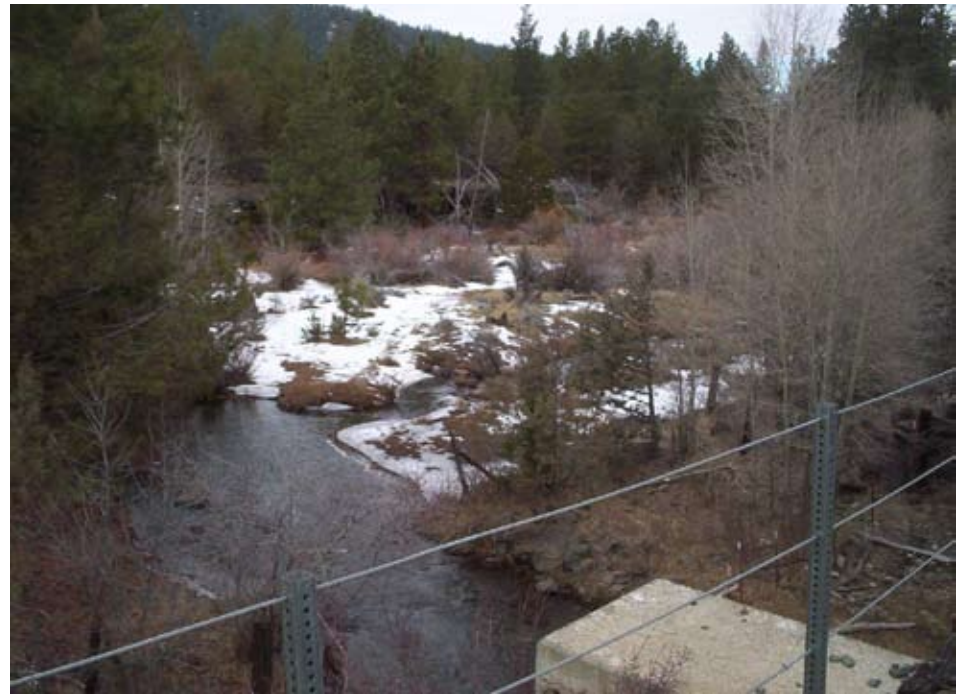
Photo D. The Johnson & Pollock railroad grade begins to climb out of the canyon along Butte Creek after crossing under the Southern Pacific tracks. Dashed line indicates location of grade. Photo February 11, 2006 by the author.

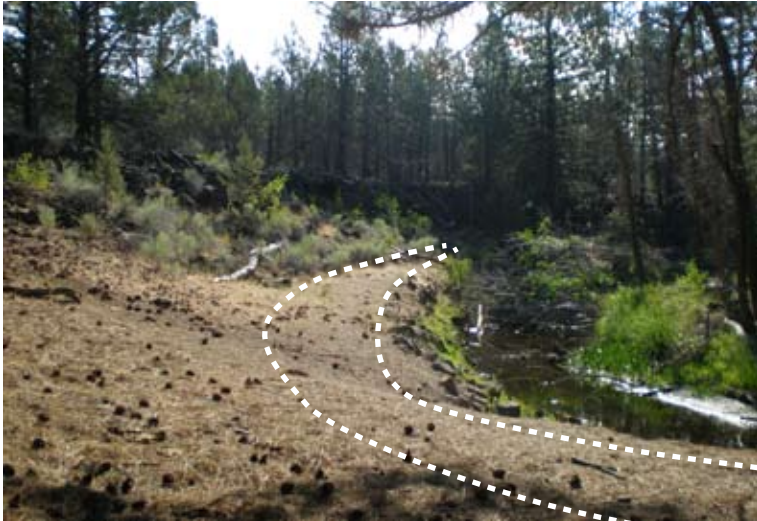
Photo E. The Johnson & Pollock railroad grade along Butte Creek. Dashed line indicates location of grade. Photo July 7, 2007 by the author.

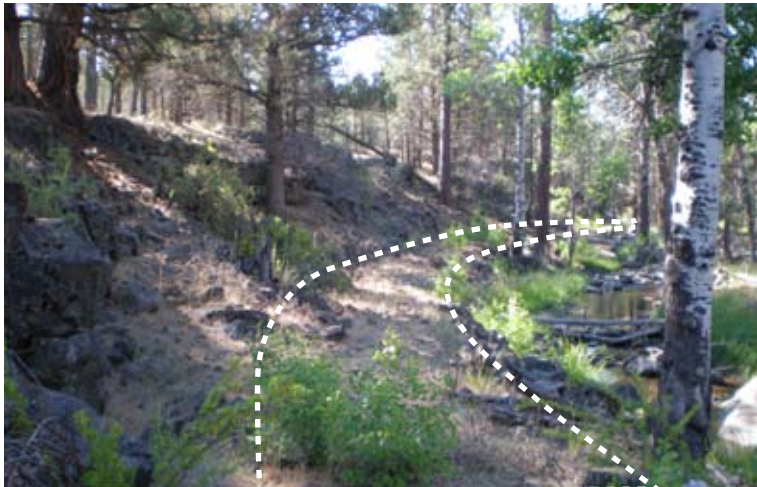
Photo F. The railroad grade along Butte Creek. Dashed line indicates location of grade. Photo July 7, 2007 by the author.

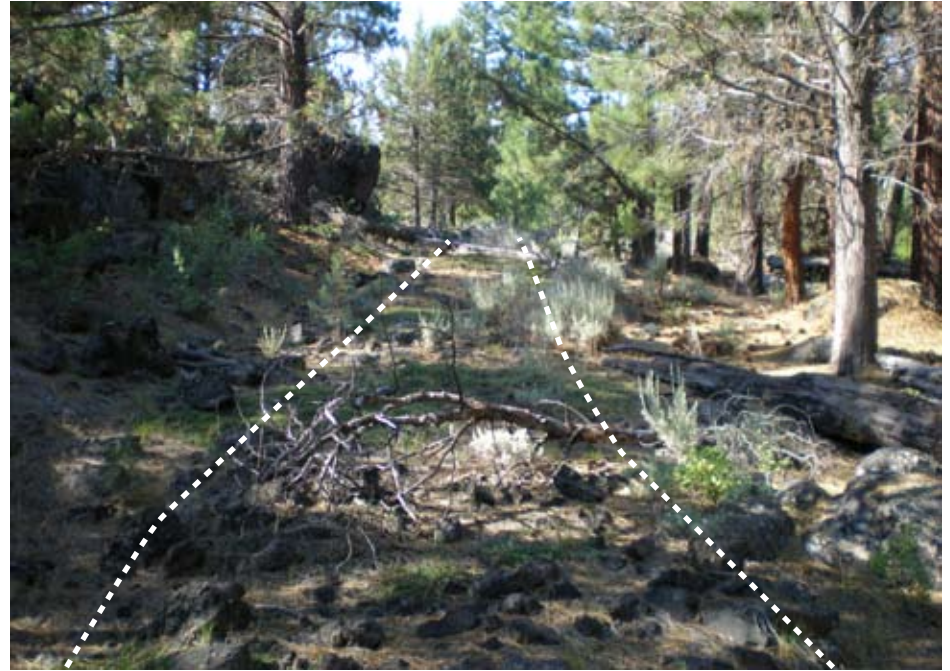
Photo G. The railroad grade along Butte Creek. Dashed line indicates location of grade. Photo July 7, 2007 by the author.

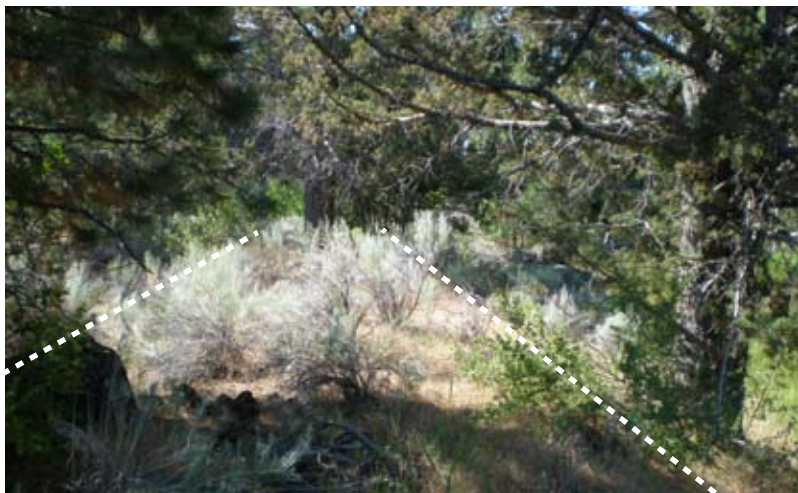
Photo H. The railroad grade climbing out of the gully along Butte Creek. Dashed line indicates location of grade. Photo July 7, 2007 by the author.

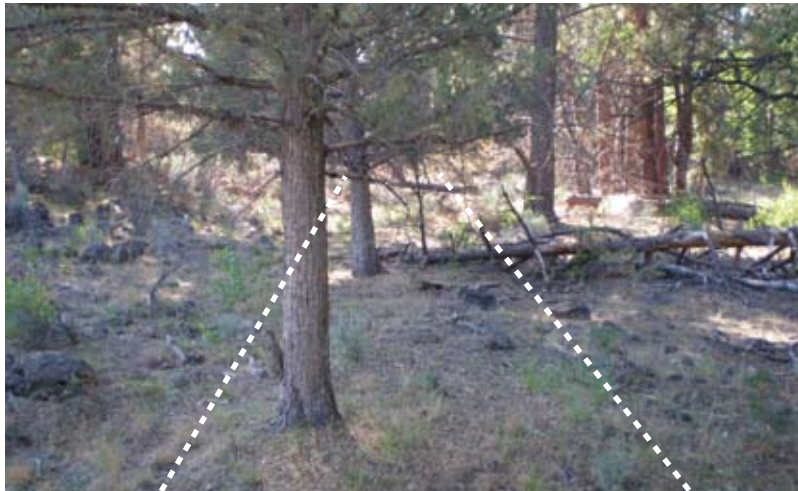
Photo I. The railroad grade approaching the fence line near the first junction. Dashed line indicates location of grade. Photo July 7, 2007 by the author.

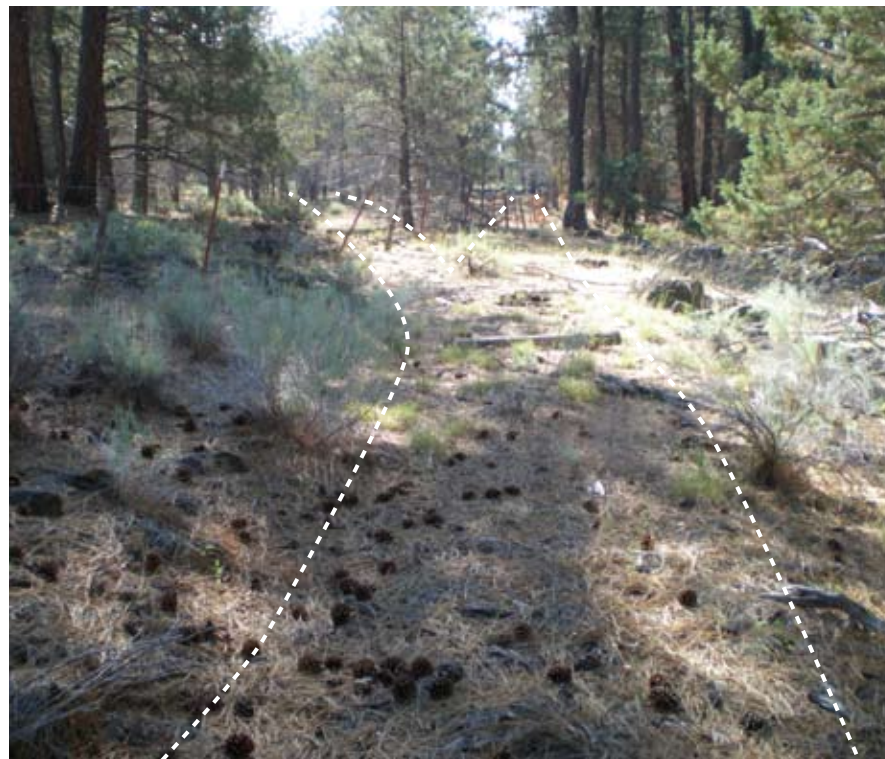
Photo J. Fence line across railroad grade near first junction. Dashed line indicates location of grade. Photo July 7, 2007 by the author.

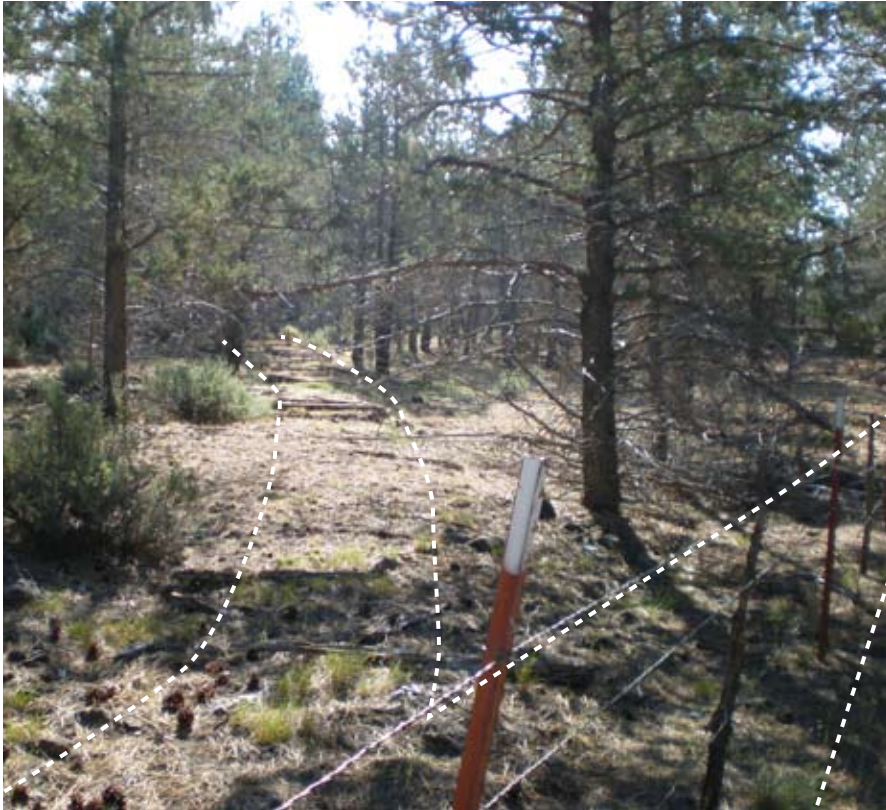
Photo K. The first junction on the Johnson & Pollock railroad. The left fork crosses the Old State Highway and continues northward to the end of track. The right fork continues southward and then turns eastward, ending in a small clearing near the edge of a meadow (see map insert, right - www.google.com). Dashed line indicates location of grade. Photo July 7, 2007 by the author.

Upon leaving the canyon, the railroad forked, with the east branch heading due east across what is now the Old State Highway. The south fork continued a short distance, ending in a small clearing just north of a meadow, possibly the site of a logging camp or log loading spur.

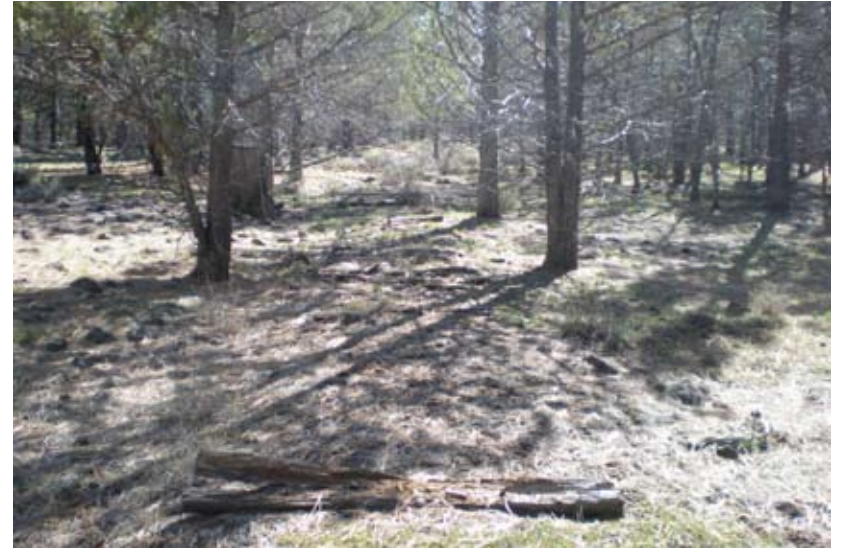
Photo L. Johnson & Pollock railroad turning eastward towards the Old State Highway. Photo April 18, 2010 by the author.

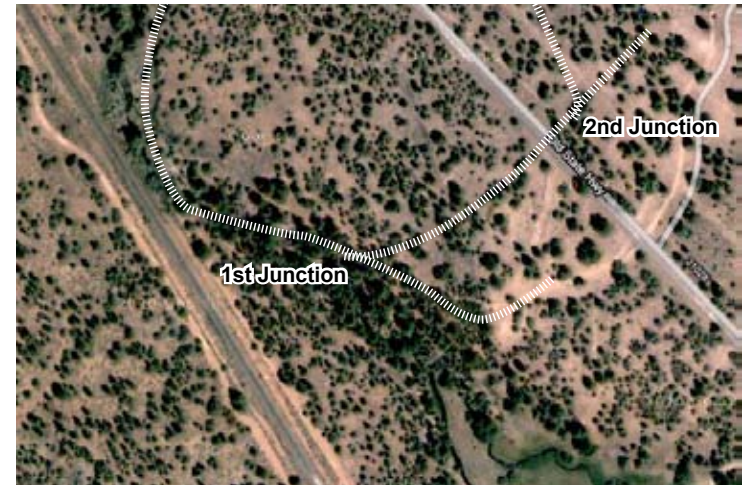
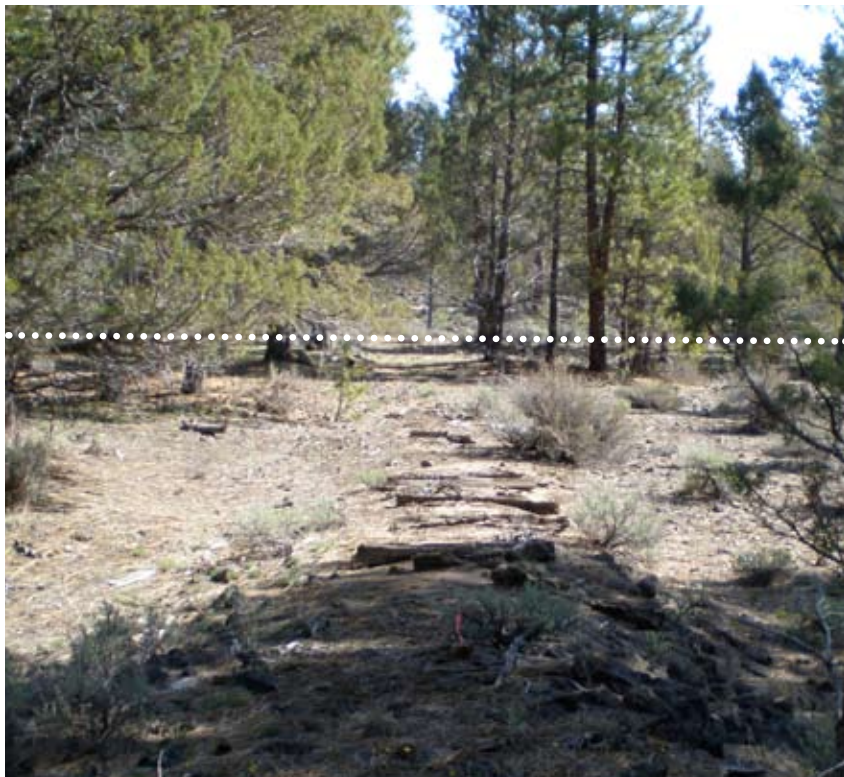
Photo M. Railroad grade approaching Old State Highway. Dotted line marks location of the road. Photo April 18, 2010 by the author.

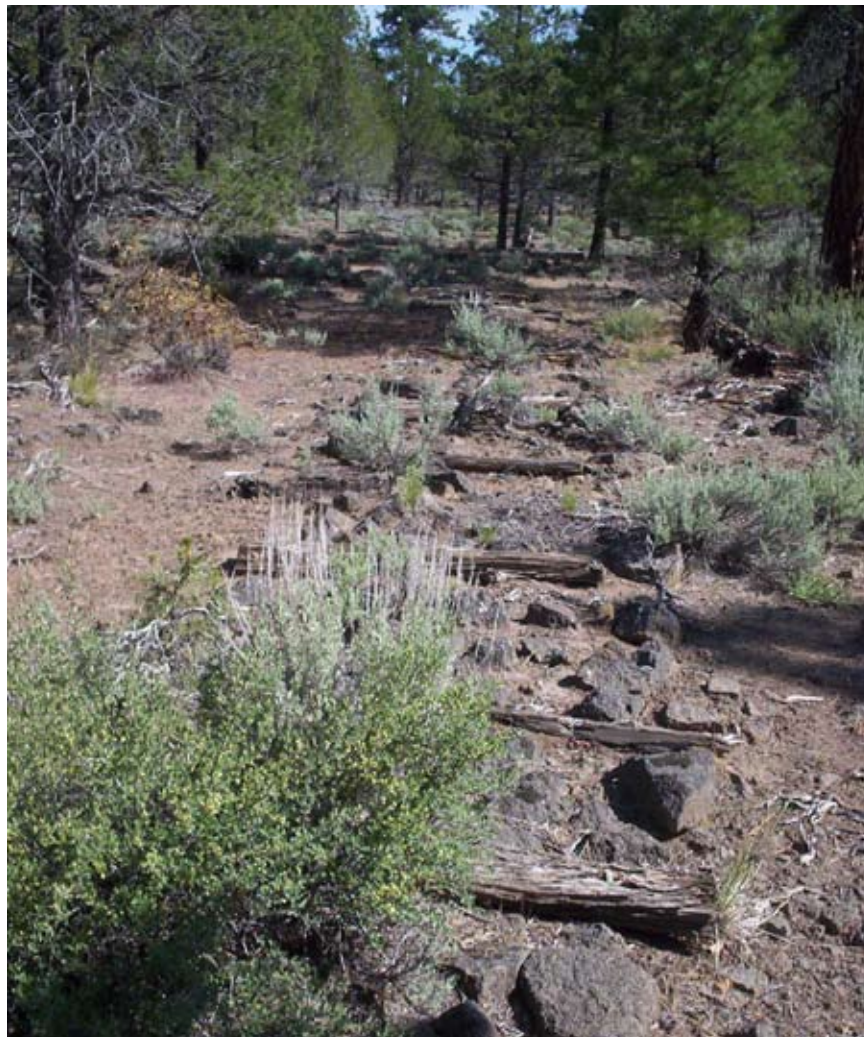
Photo N. Railroad grade turning northward after crossing the Old State Highway. Photo June 11, 2006 by the author.

After crossing the Old State Highway, the railroad turned northward. There was another spur continuing a short distance eastward across this meadow. A few old cans with solder holes, which date around the time of Johnson & Pollock operations, are scattered through this area, indicating the possible site of a logging camp.

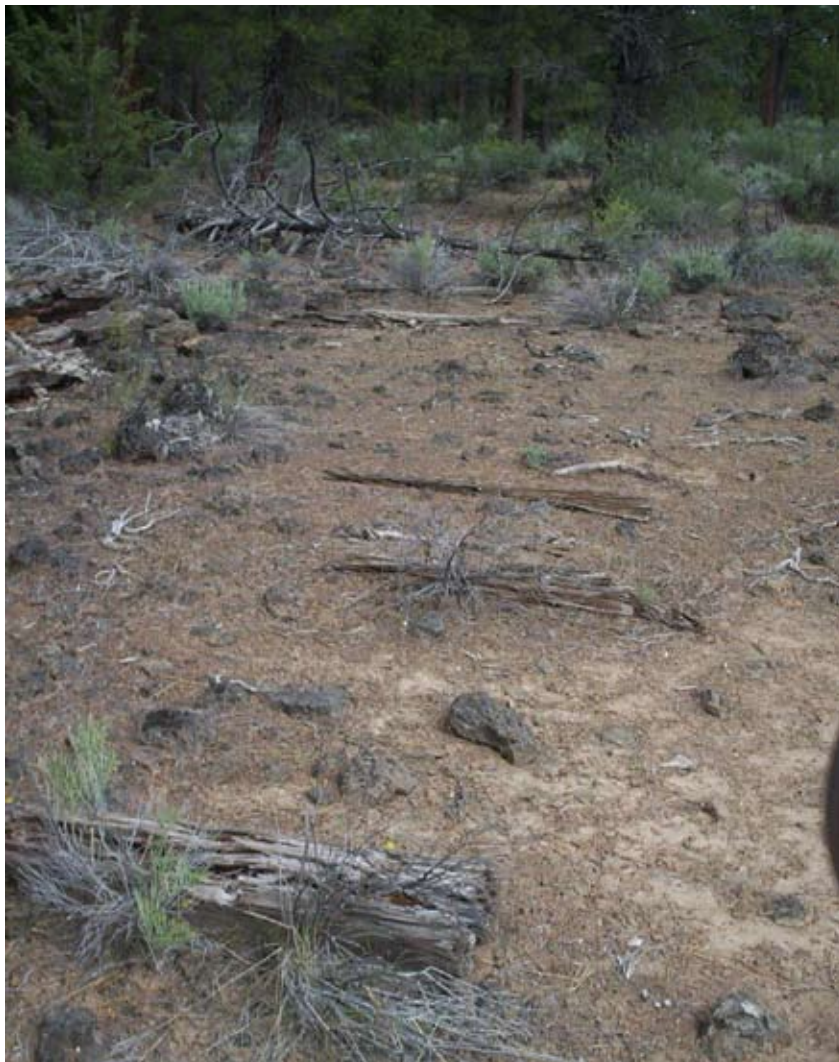
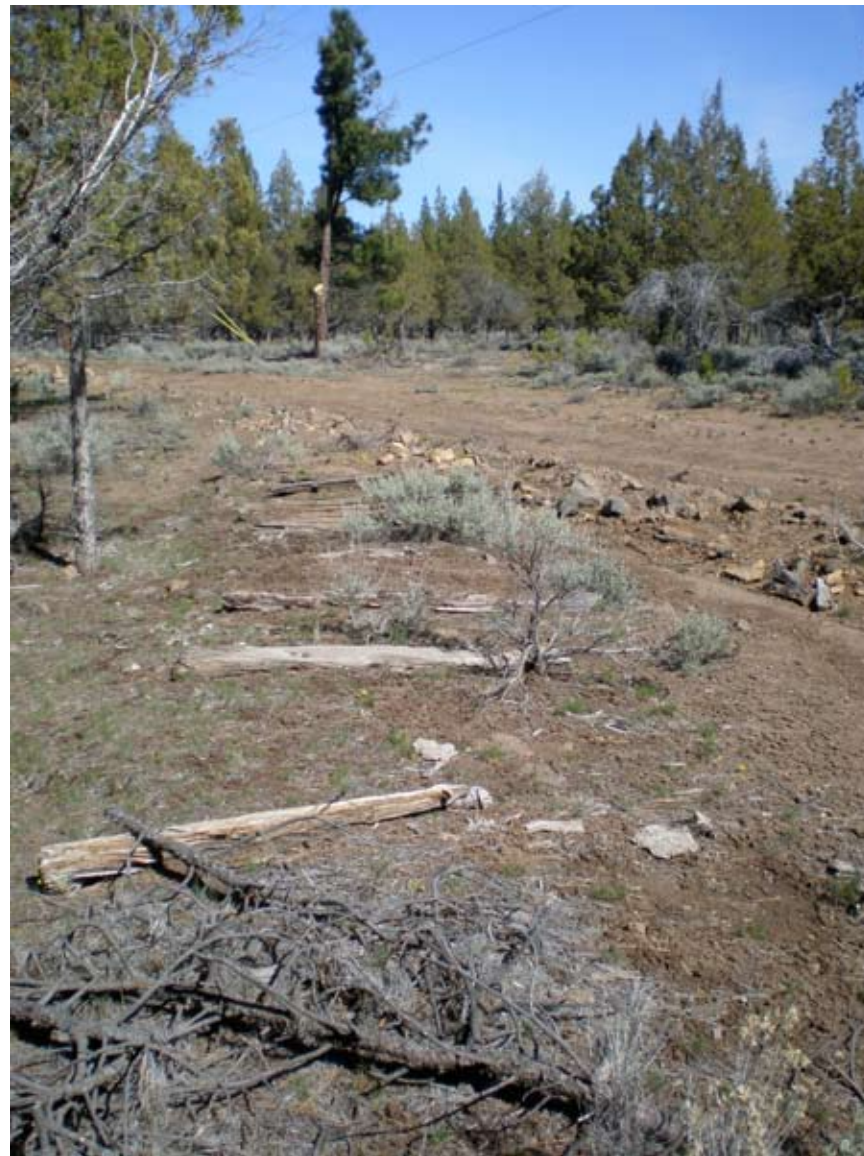
Photo O (above). Railroad grade turning northward after crossing the Old State Highway, June 6, 2006. Photo P (right) Grade crossing under power line. Photo April 18, 2010 by the author.

After crossing today's Old State Highway, the railroad turned northward, paralleling the road. Directly east of Jerome, the railroad forked once again and continued eastward up a gradual slope to a low saddle overlooking Butte Valley, where the railroad ended.

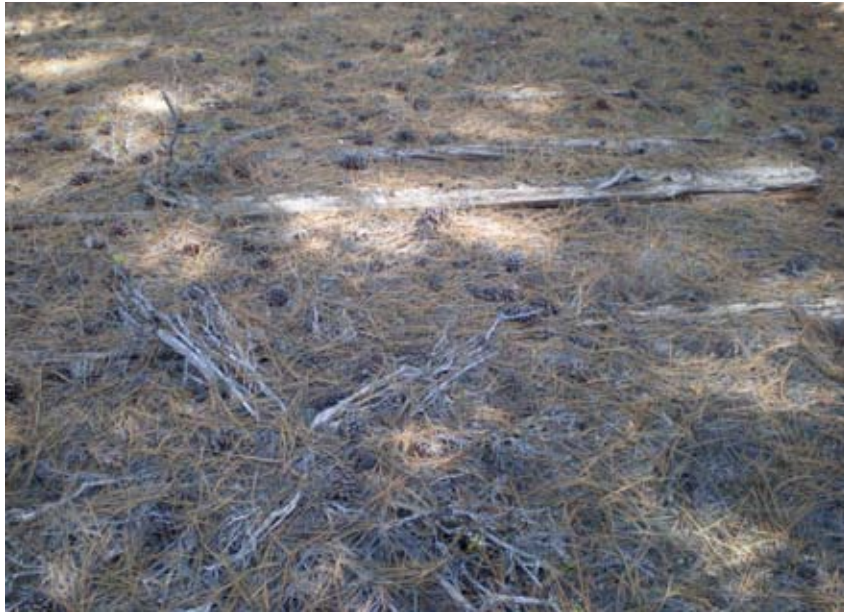
Photo R. Long switch ties mark the location of the third junction on the Johnson & Pollock logging railroad. All other ties were only 5' long. Photos 4-18-2010 by author.

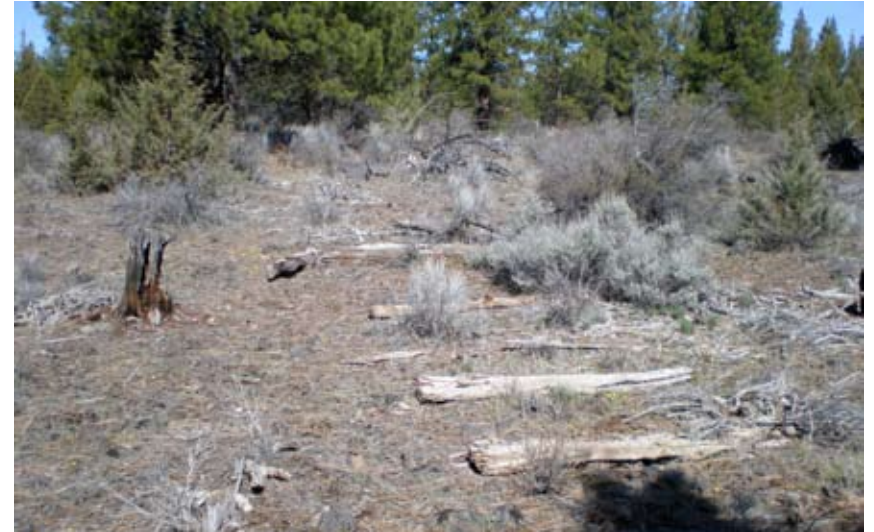
Photo Q. Johnson & Pollock railroad grade north of the power line is indistinct in many areas and was located only by the remains of railroad ties. Photos 4-18-2010 by author.

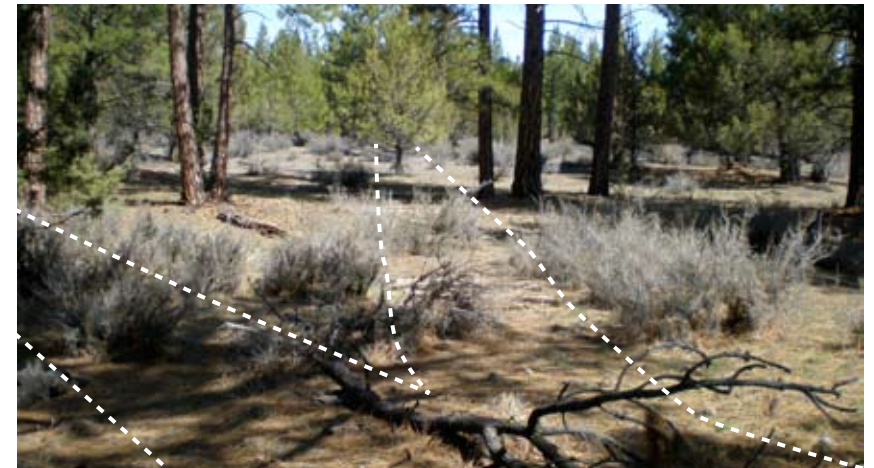
Photo S. View at third junction. Grade is very indistinct Dotted line indicates location of railroad grade. Photos 4-18-2010 by author.

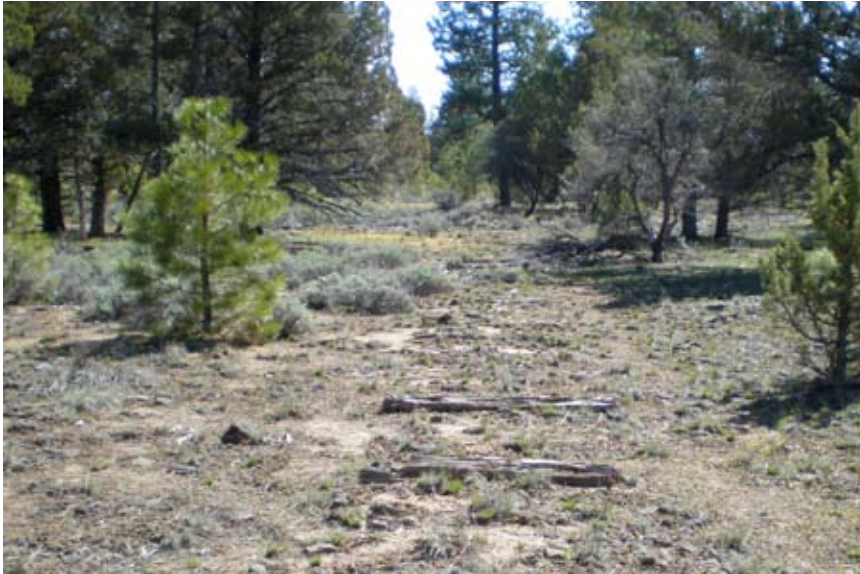
Photo T. Johnson & Pollock railroad grade east of the third junction. Photo 4-18-2010 by author.

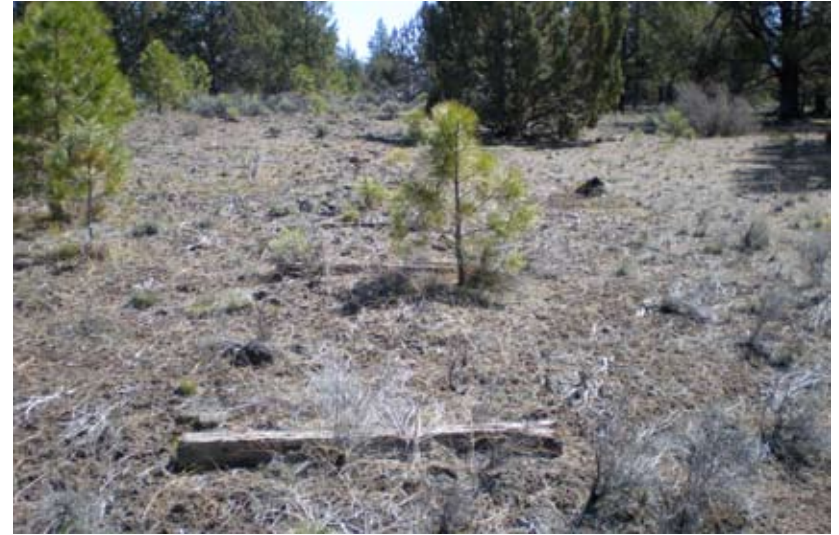
Photo U. The railroad grade climbed a gradual slope east of the third junction. Photo 4-18-2010 by author.

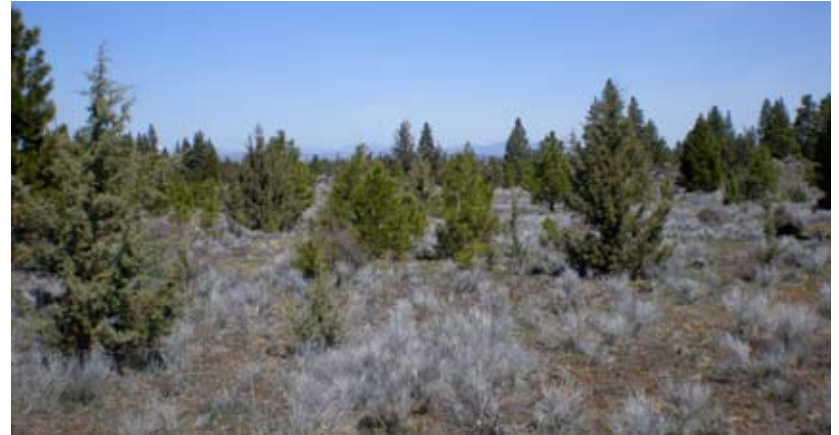
Photo V. The Johnson & Pollock railroad grade ended in this low saddle. Photo 4-18-2010 by author.
